FIX THESE XENTRY FAULT MESSAGES WHEN DOING SCN ONLINE:

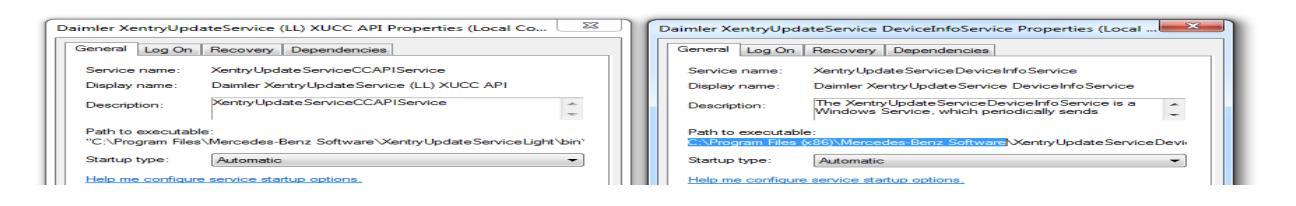
3. **For XENTRY Windows 32bit only**. Sometimes, an addon, update and install the service(s) with path to 'C:\Program Files (x86)\'. You have to edit and fix the path of that service(s).

In this case, click on Start Menu -> Run and enter "Regedit". Then you need to navigate to HKEY_LOCAL_MACHINE\SYSTEM\CurrentControlSet\Services\[Name of Service]. To change the location of the exe, just change the "ImagePath" key.
